# Manhole Inspection Summary

Manhole # S63Y\_\_002MH

**Inspection** ☐ Is Incomplete Rating: **3) Fair**

**Location** Address: **Keith Ave. on railroad tracks.**

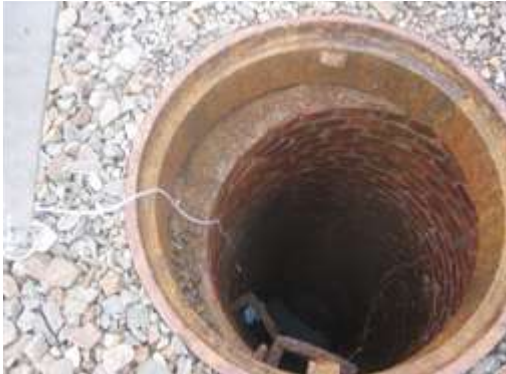
Defect 1

Frame adjustment 6 inches

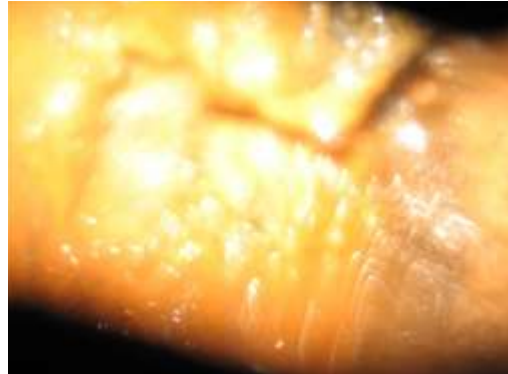
Defect 6

infiltration of wall

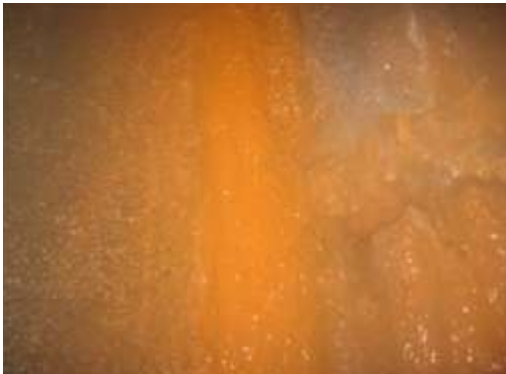
Defect 3

Infiltration of ground water in chimney wall

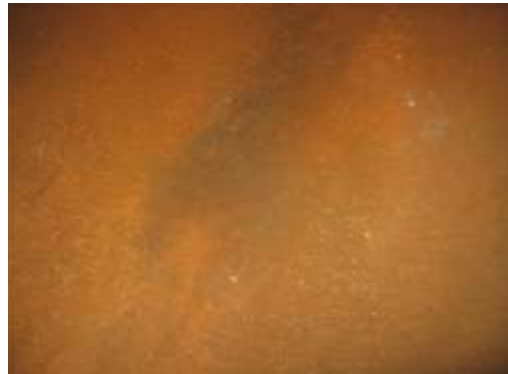
Defect 2

wall infiltration

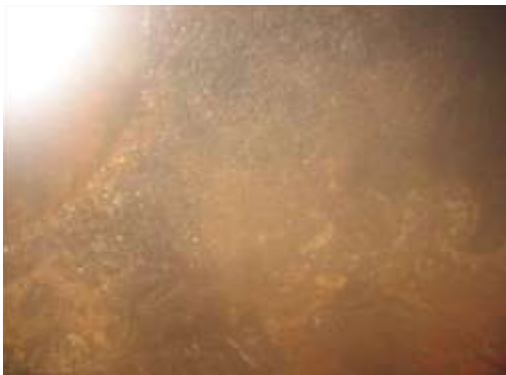
Defect 4

wall infiltration

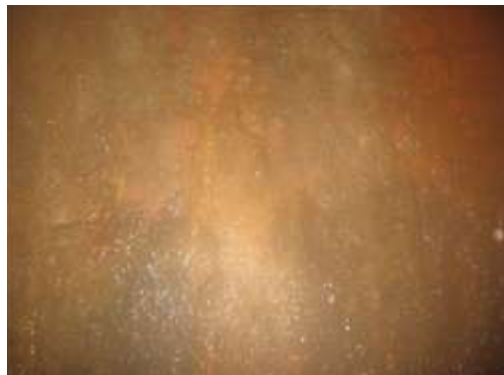
Defect 5

infiltration and encrustation

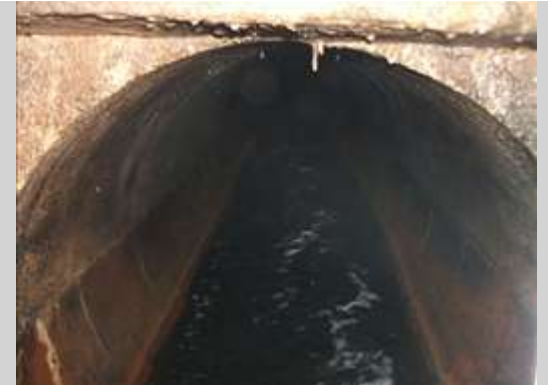
12 O'Clock Outflow

Pipe Height: **42** (in.) Rod and Bar (Angled)  
Pipe Material: **Concrete** ☐ Pipe Lined  
Invert Depth: **29.42** (ft.) Flow Characteristics: **Slow**  
Deposits: ☐ None ☐ Mud ☒ **Sludgy** ☐ Debris ☐ Grease  
Silt Depth: **0.25** (in.) Deposits Extent: **Light**  
Infiltration: **None** Pipe Seal Cond: **Sound**

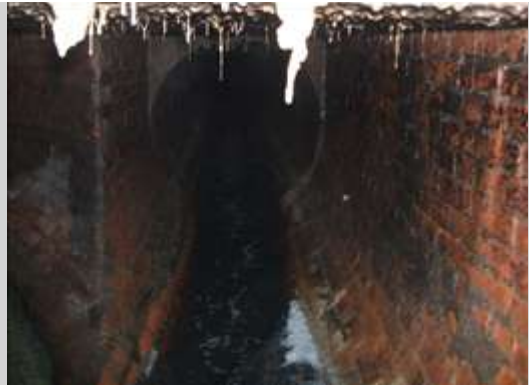
6 O'Clock Inflow

Deposits: ☐ None ☐ Mud ☒ **Sludge** ☐ Debris ☐ Grease

Silt Depth: **0.25** (in.) Deposits Extent: **Light**
